Inspection Report No: 4610

Property Address: 72 Mirambeena Street, Belmont North.

The Standard Property Report (Except ACT) Complies with Australian Standard
AS 4349.1- 2007 Inspection of Buildings Part 1: Pre-Purchase Inspections –
Residential Buildings

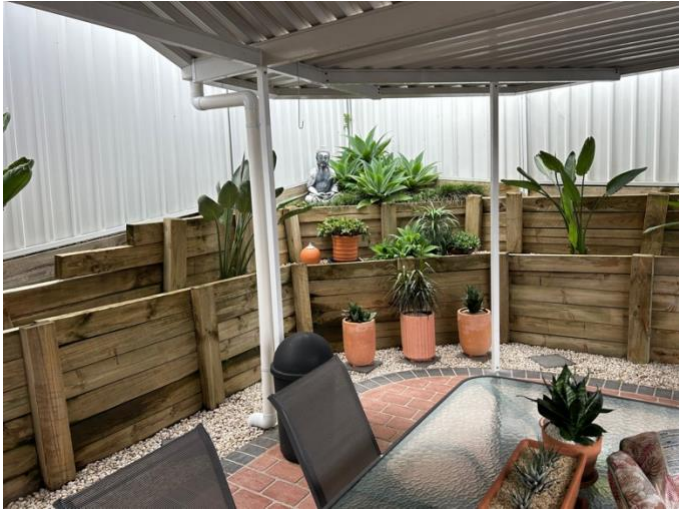
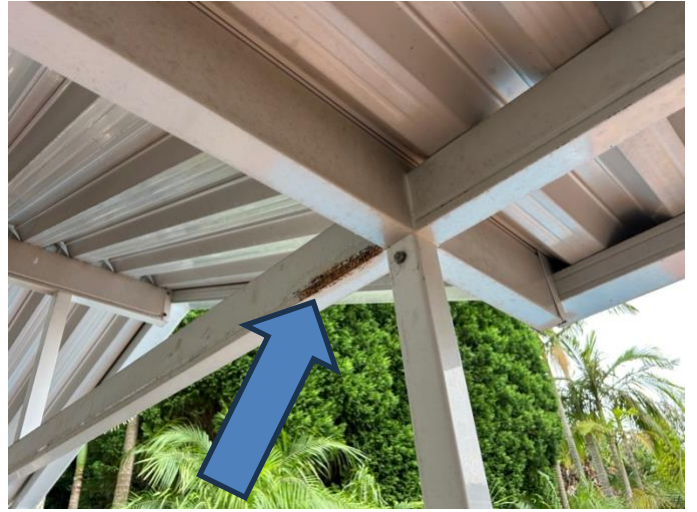
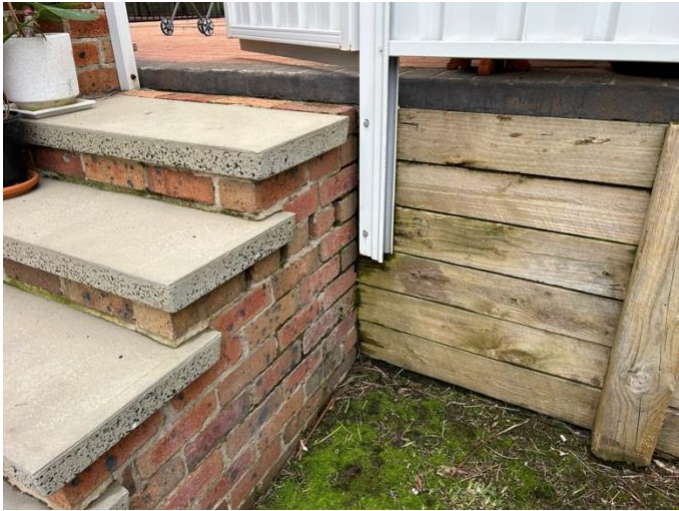
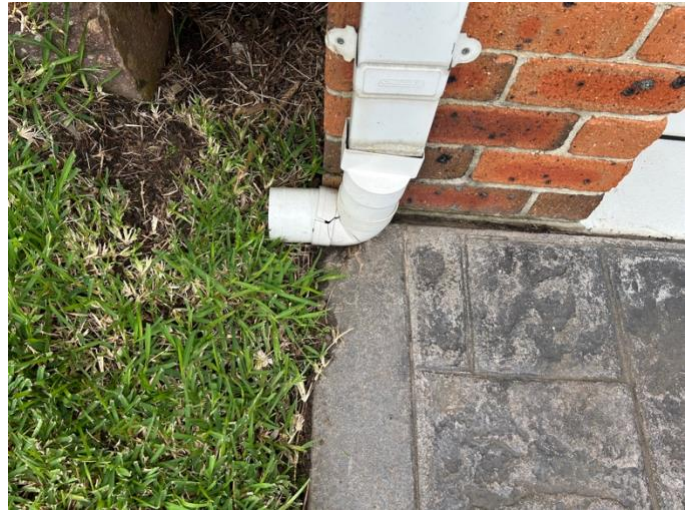
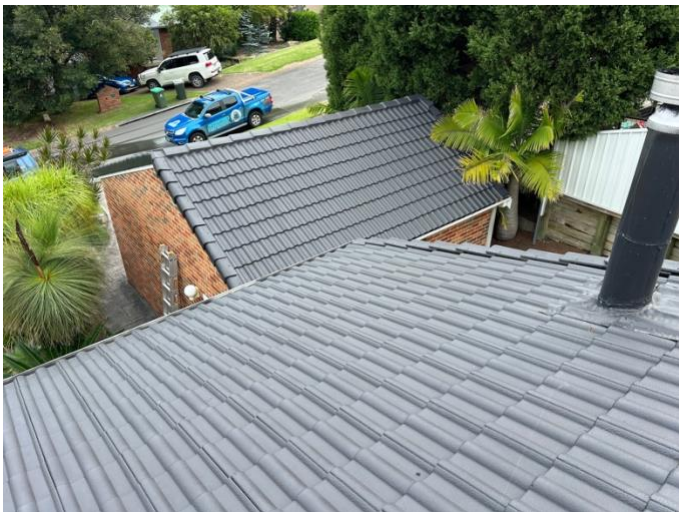
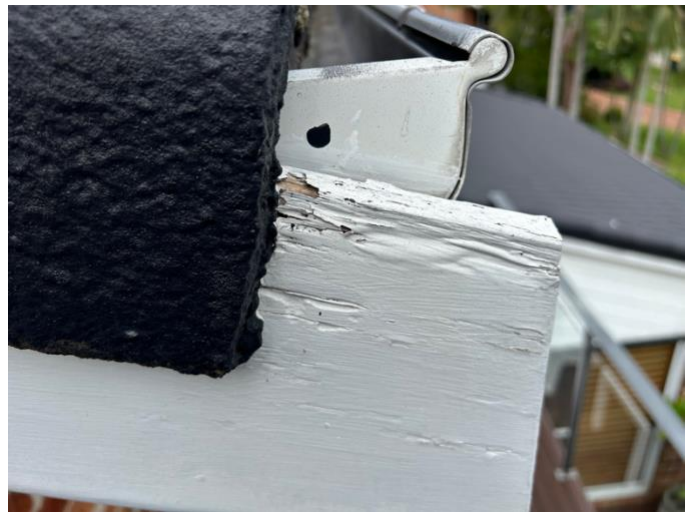
- Minor cracking noted to the perimeter pavement.
- Isolated area of corrosion noted to the pergola frame. (Photo page 6)
- Areas of minor to significant rotation noted to the upper treated pine terracing as per the summary. (Photo page 6)

- Meter box; RCD safety switches noted; however, protect circuit/s are not properly identified. Consult a licensed electrician for further advice.
- Consider handrail installation at top of step treads where the adjacent ground level exceeds 1000mm. Beware of fall hazards. (Photo page 6)

- The roof tiles and capping appeared in generally good serviceable condition. (Photo page 6)
- Gutters and downpipes appear in generally good serviceable condition.
- Minor decay noted to the barge end. (Photo page 6)
- Impact damage noted to one polycarbonate pergola skylight sheet.

- Minor impact damage noted to isolated area of the garage door panel.
- Automatic garage door opener fitted.
- Unconnected downpipe noted off the SW corner; however, generally directed away from the building structure. (Photo page 6)
- Fine cracking to .5mm noted to the floor slab. (Photo page 9)

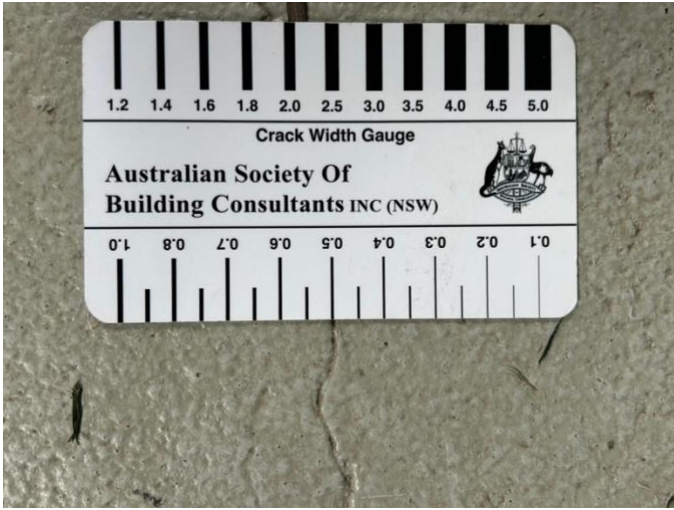
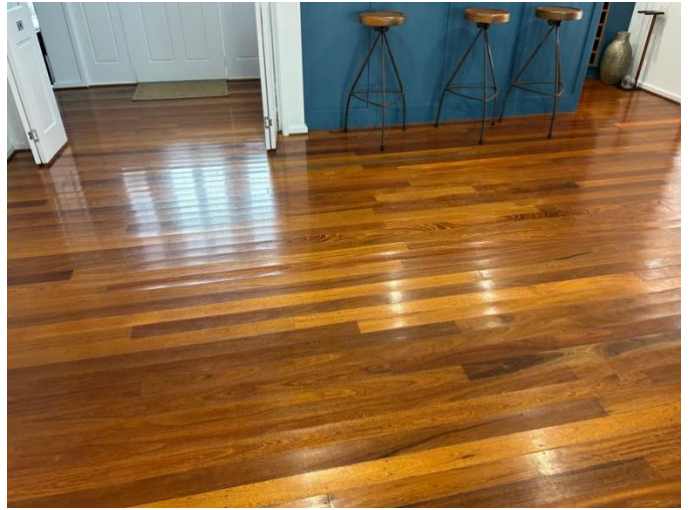
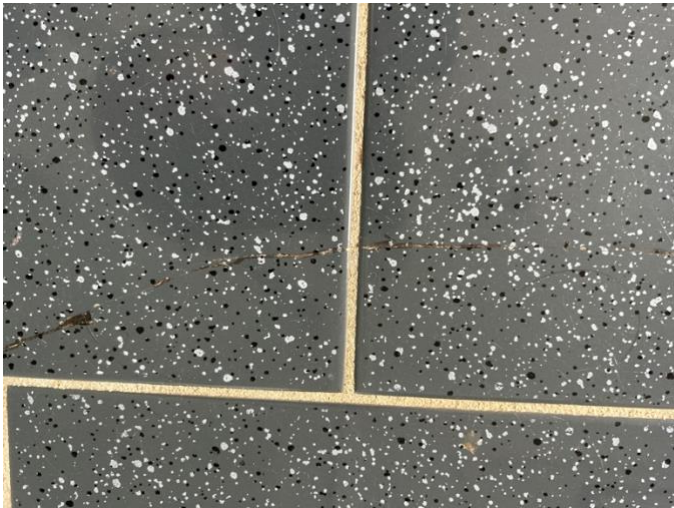
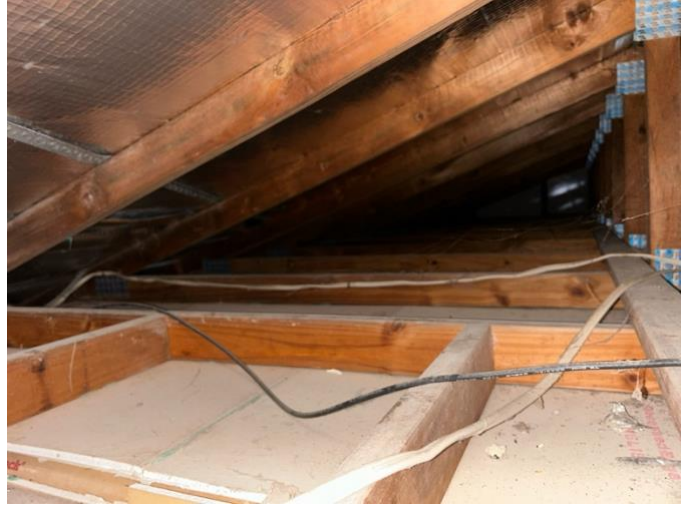
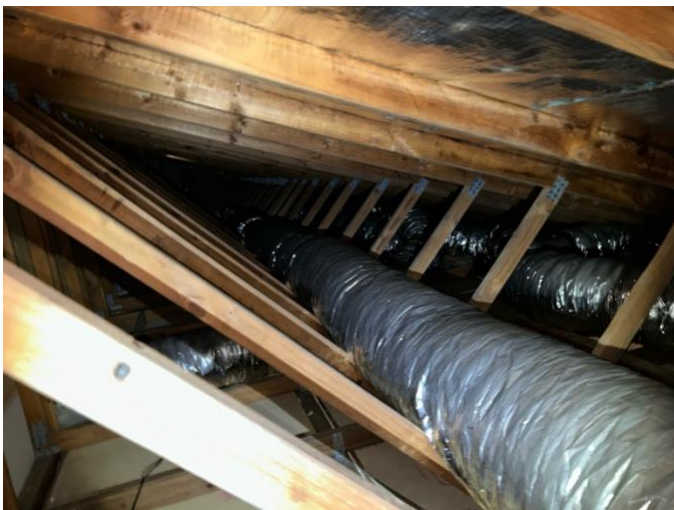
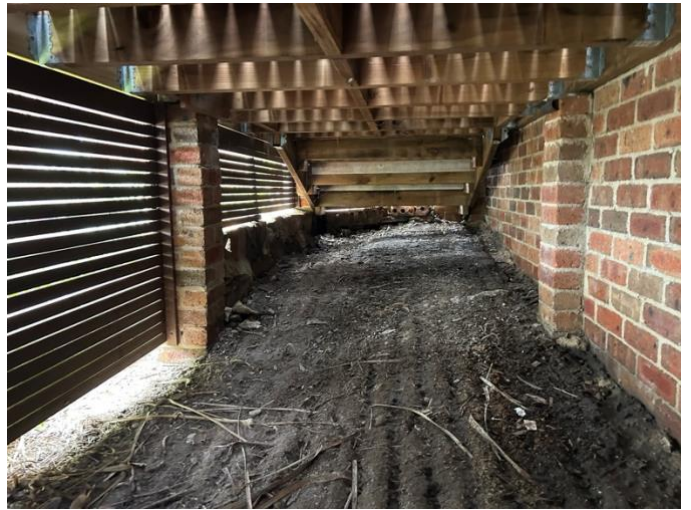
- Typical minor cupping noted to the floorboards. (Photo page 9)

- Fine cracking noted to the floor tiles. (Photo page 9)
- Moulded shower base noted.
- Consider replacing sash rollers as per the summary.

- The roof frame appears generally true and adequately braced. (Photo page 9)
- Sarking installed to the underside of the roof tiles.
- No insulation material installed over the ceiling linings. (Photo page 9)
- No roof ventilation noted.

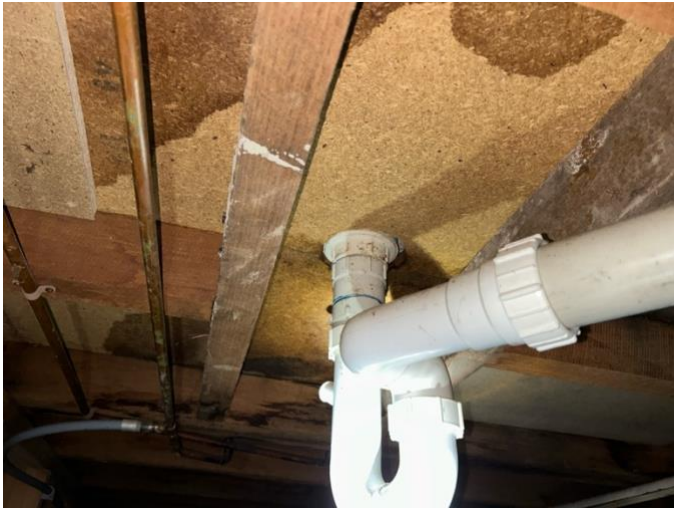
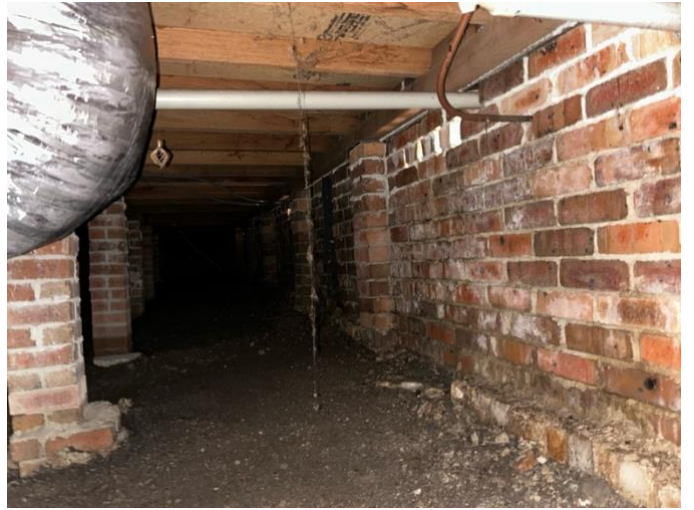
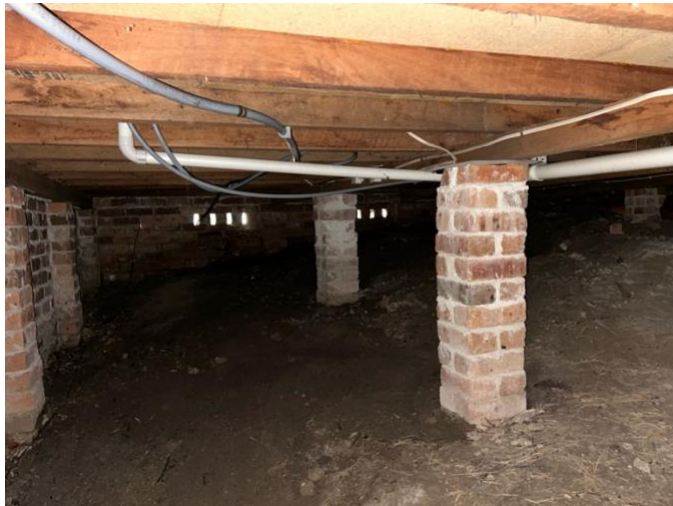
- The bearers and joists appear in generally sound condition.
- Minimal differential settlement noted to the isolated piers. (Photos page 10)
- Previous water stains noted adjacent main bathroom floor area. (Photos page 10)
- Pier caps and continuous appear in generally good serviceable condition despite areas of corrosion to the continuous/pier capping (typical).
- 315lt mains pressure electric HWS. Date of manufacture 05/21.
