# Inspection Report

## Allround Pest Management

**72 Mirambeena Street, Belmont North, NSW, 2280**

## TIMBER PEST INSPECTION

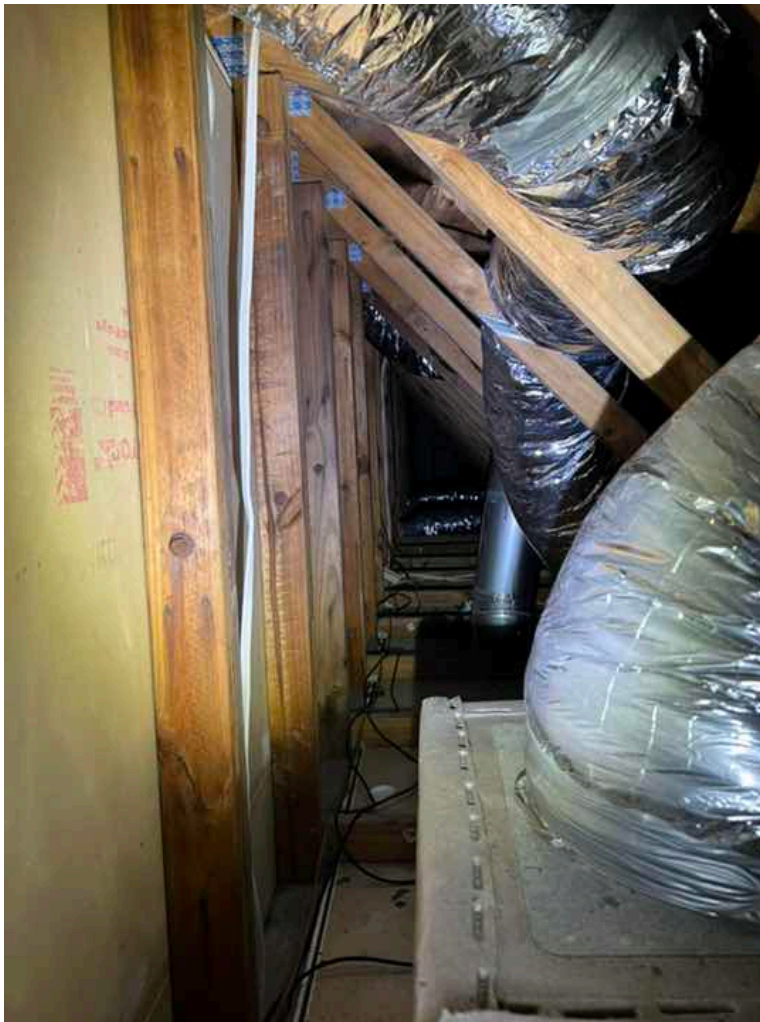
Insulation batts

Bulk insulation restricting view of roofing timbers.

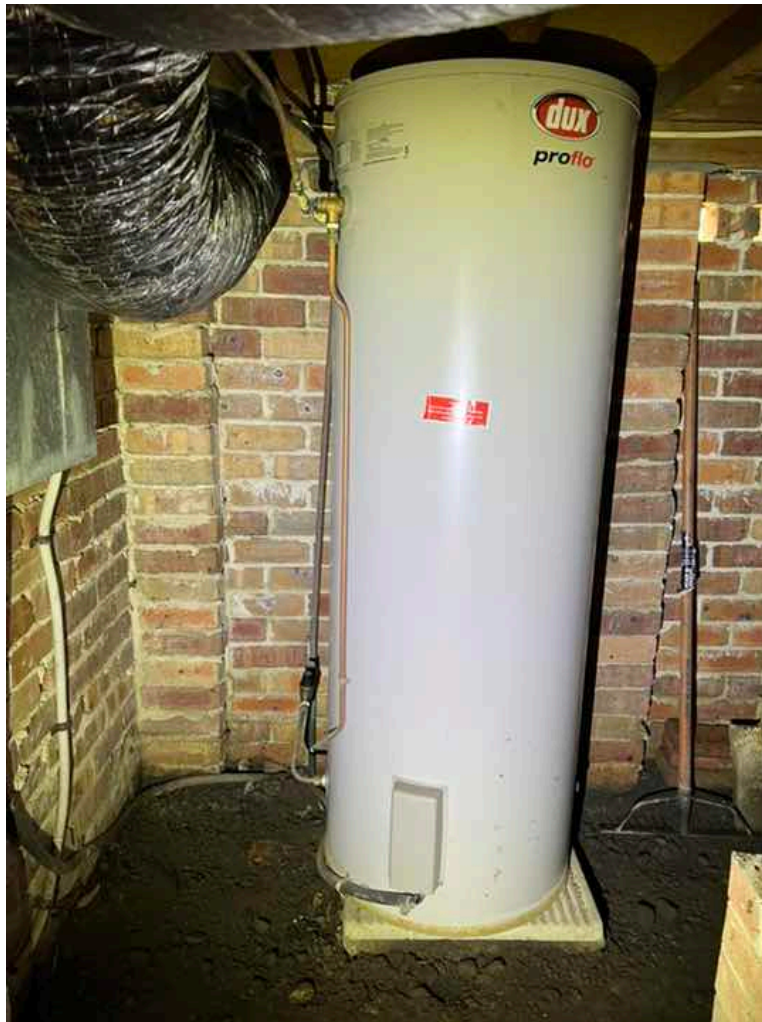
#### **Was the overflow sufficiently drained**

No - Divert hot water overflow away from the building perimeter

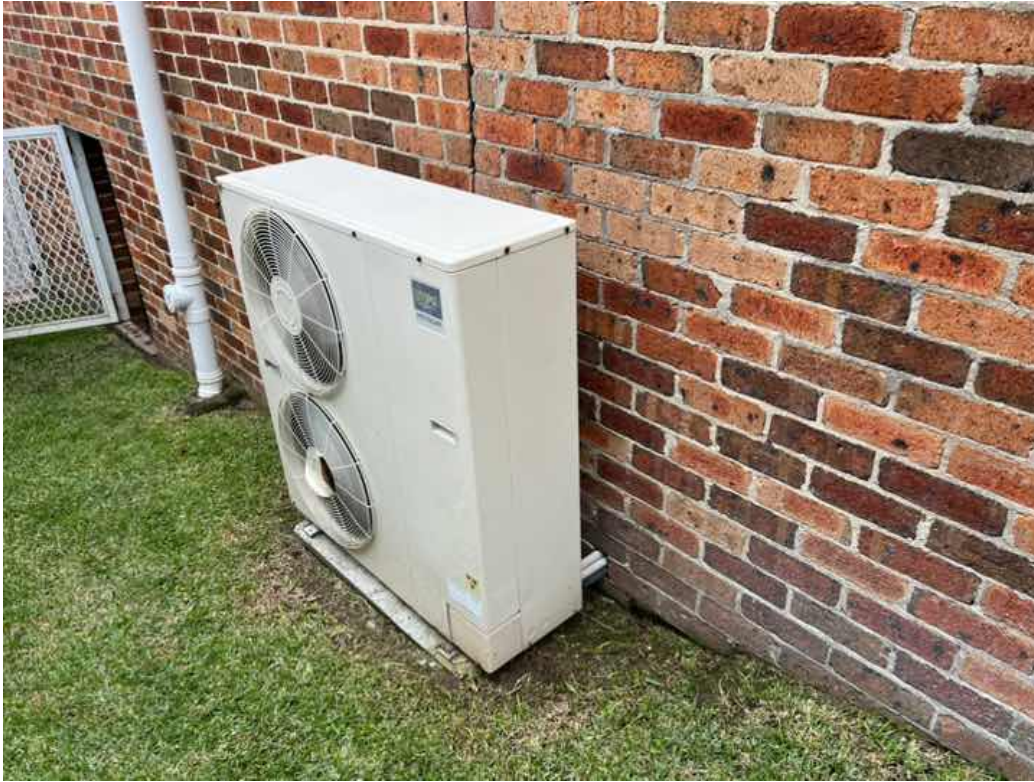
**Was the Air Conditioner Sufficiently Drained**

Yes
